Removing Jammed CD's from GL1800 CD Changer.

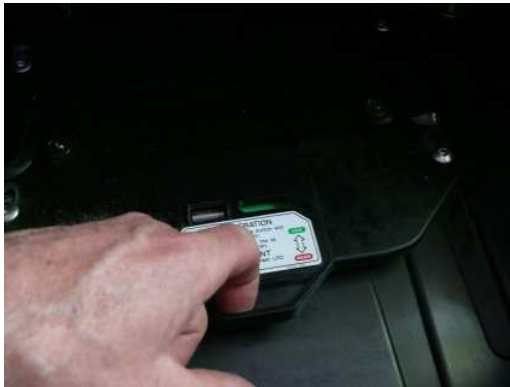
Fig-1

Step-1 Open trunk and pull changer top cover towards rear of bike and lift up. Fig's-1 & 2

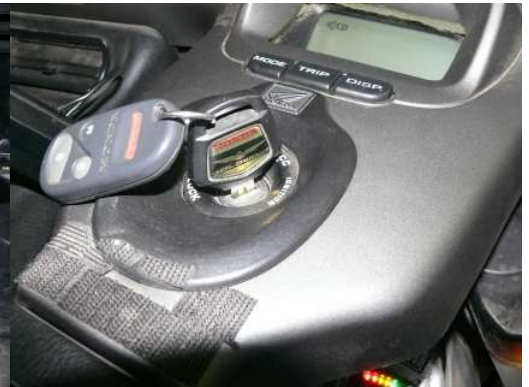
Step-2 Turn ignition switch to ACC position. Fig-3

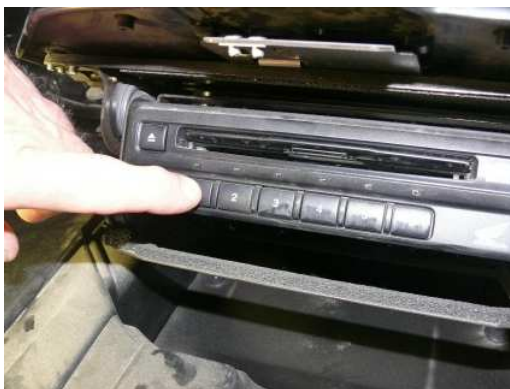
Step-3 Push one of the number buttons on changer unit to select a CD to be removed. Fig-4

Eject other CDs by performing step-3 and step-4

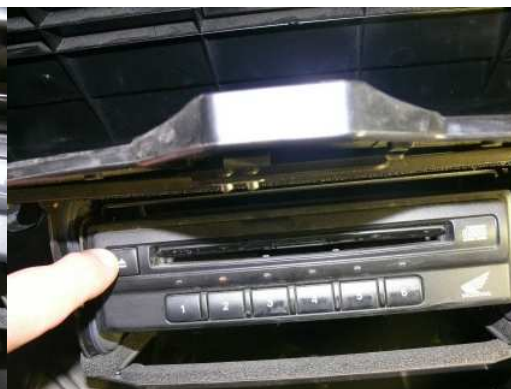
Step-4 Push the EJECT button on changer and listen for changer to cycle. Fig-5

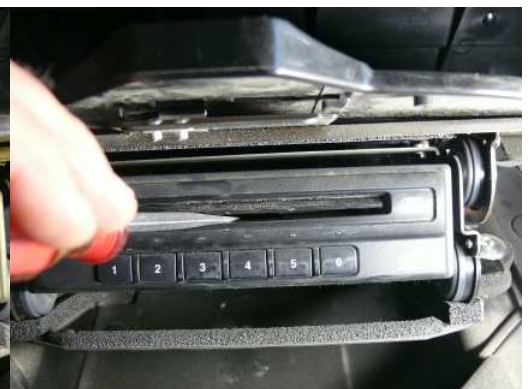
Push EJECT button and while changer is attempting to eject, look into the slot for the edge of the CD.
(The door should be open.) Use a flashlight to look into the slot as the CD may be down inside the slot a ways.

Use a thin piece of wood or thin screwdriver to "GENTLY" nudge the CD inward and slightly downward allowing the CD to move outward. (This should be done while changer is making the eject cycle noise.)

See Fig-6

NOTE: Use care not to damage the CD or the internal mechanism of the changer. The CD should not be more than a half inch or less inside the slot.
